Consumer Product Service
Manager of Technical Support
UPGRADE BULLETIN

MODEL: ATARI 400/800 COMPUTERS

GTIA Chip

Revision B, Operating System ROMs.

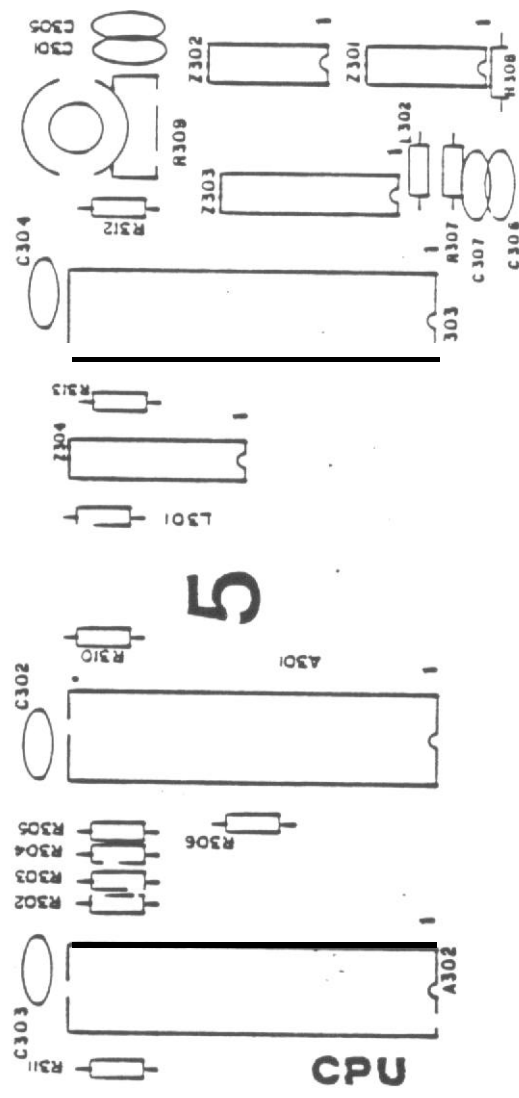
CPU Board Silkscreen

Part Location - CPU printed circuit board location A301.

Remove CO12295 from location A301 on CPU printed circuit board.

Install CO14805 in location A301 on CPU printed circuit board.

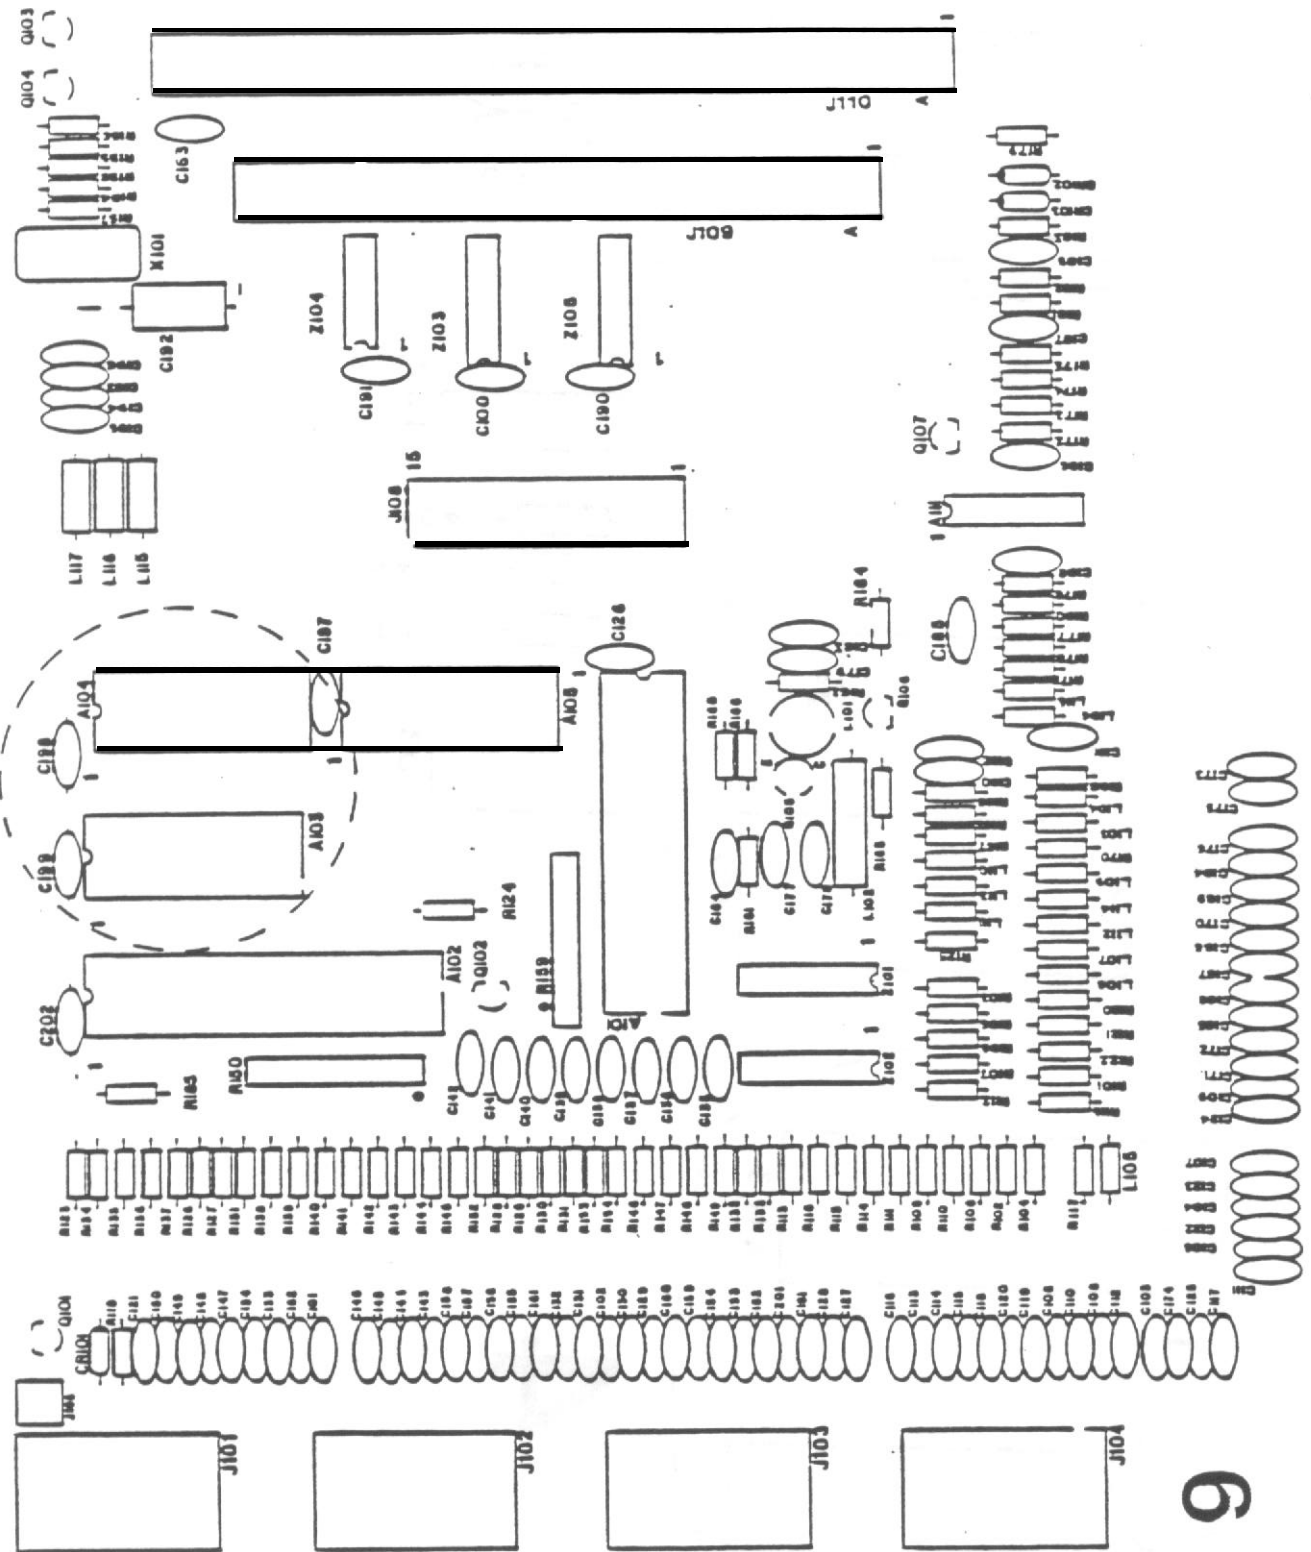
400 Motherboard Silkscreen

400 Computer System - Motherboard location
A103 (C014599) and A104 (C012499)

Remove ROM chips located at A103 (C014599A) and A104 (C012499A).

Replace C014599A and C012499A with A103 (C014599B) and A104 (C012499B).

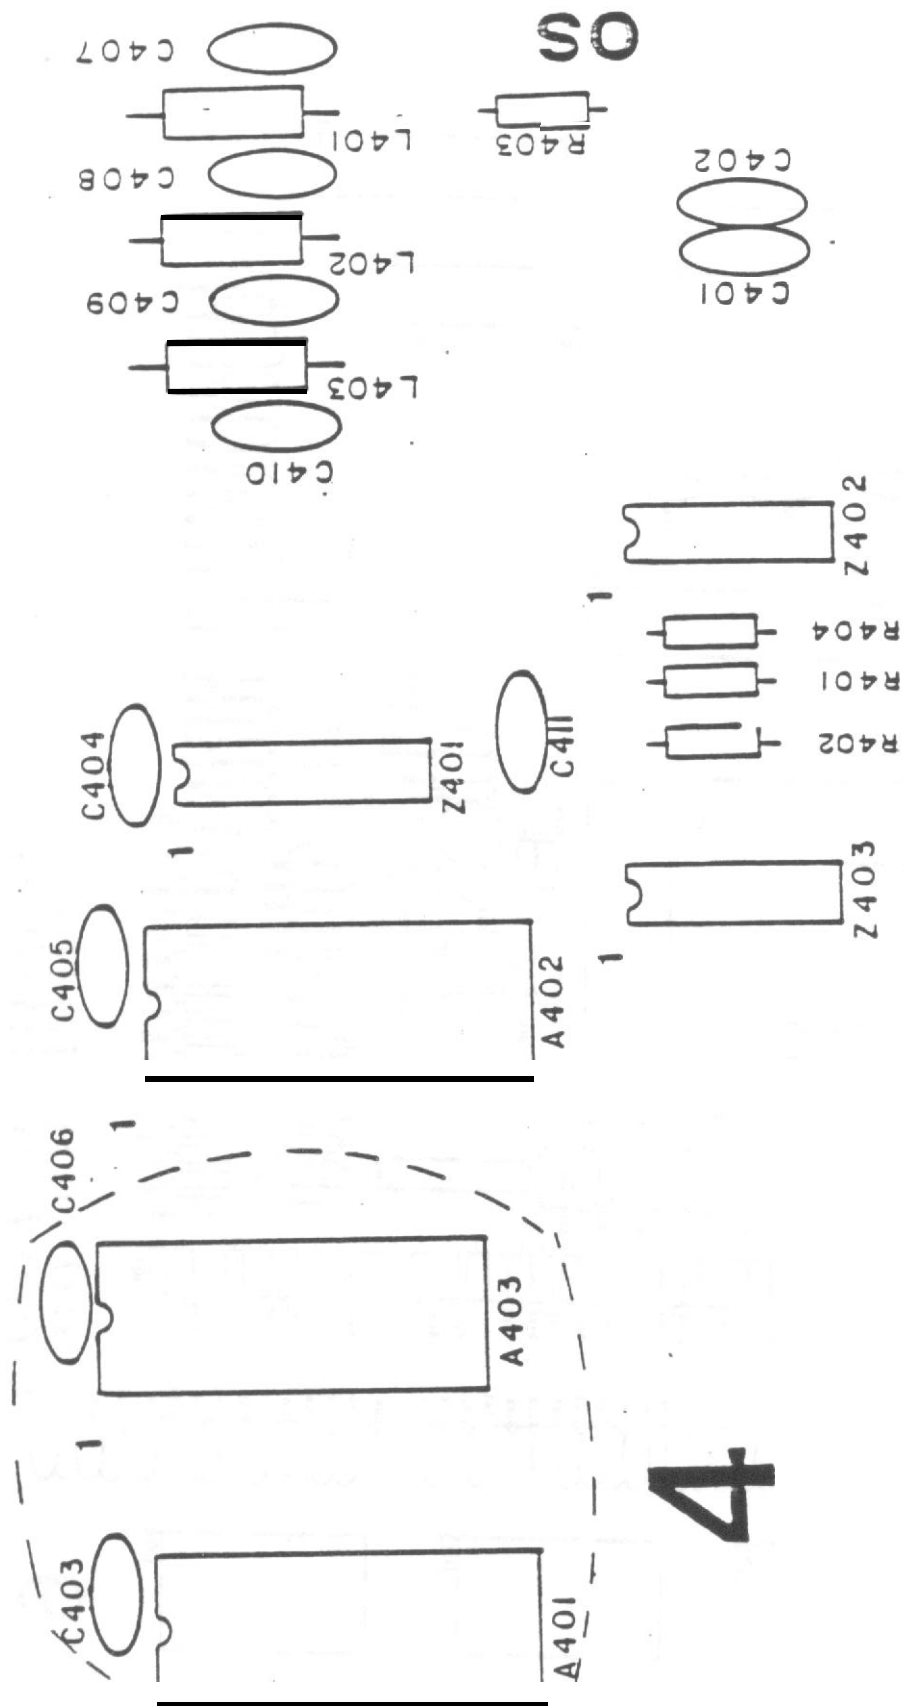
800 Computer System - Personality Board Location
A401 (C014599) and A403 (C012499).

Remove ROM chips located at A401 (C014599A) and A403 (C012499A) on ROM module.

Replace C014599A and C012499A with A401 (C014599B) and A403 (C012499B).
