Consumer Product Service
Manager of Tehnical Support
FIELD- CHANGE ORDER number 1

MODEL: Atari 810 Disk Drive

DATE: May 28, 1982

Rear Board, Molex Connectors Removal

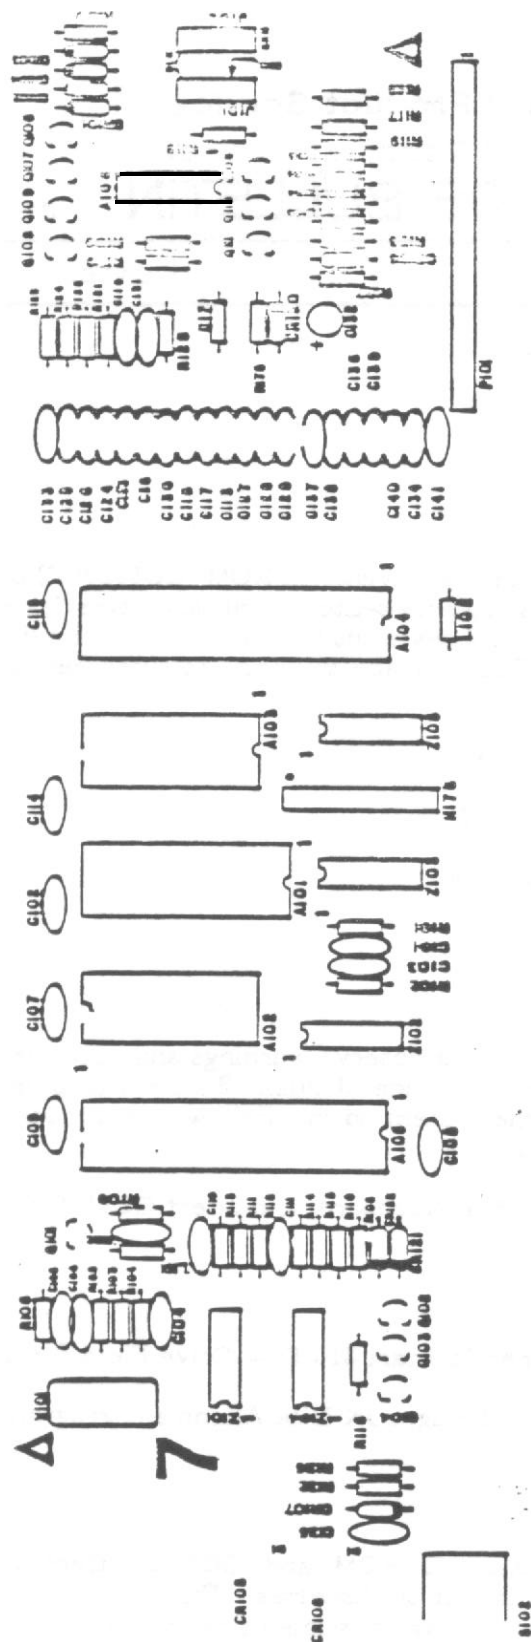
Silkscreen 810 Side Board

New units manufactured by Atari contain a Revision C ROM (**CO11299C**) on the sideboard (**CA014834**). This new ROM improves diskette sector layout and gives faster access time. Consumers may wish to replace old ROM revisions (**CO11299B**) with Revision C ROM for improved Disk Drive performance. This Upgrade Bulletin instructs **Service** Dealers who install this component.

Part Location - Sideboard, **CA01 4834**
Location **A102**

Remove **CO11299B** from Location **A102** on sideboard, and insert **CO11299C**.

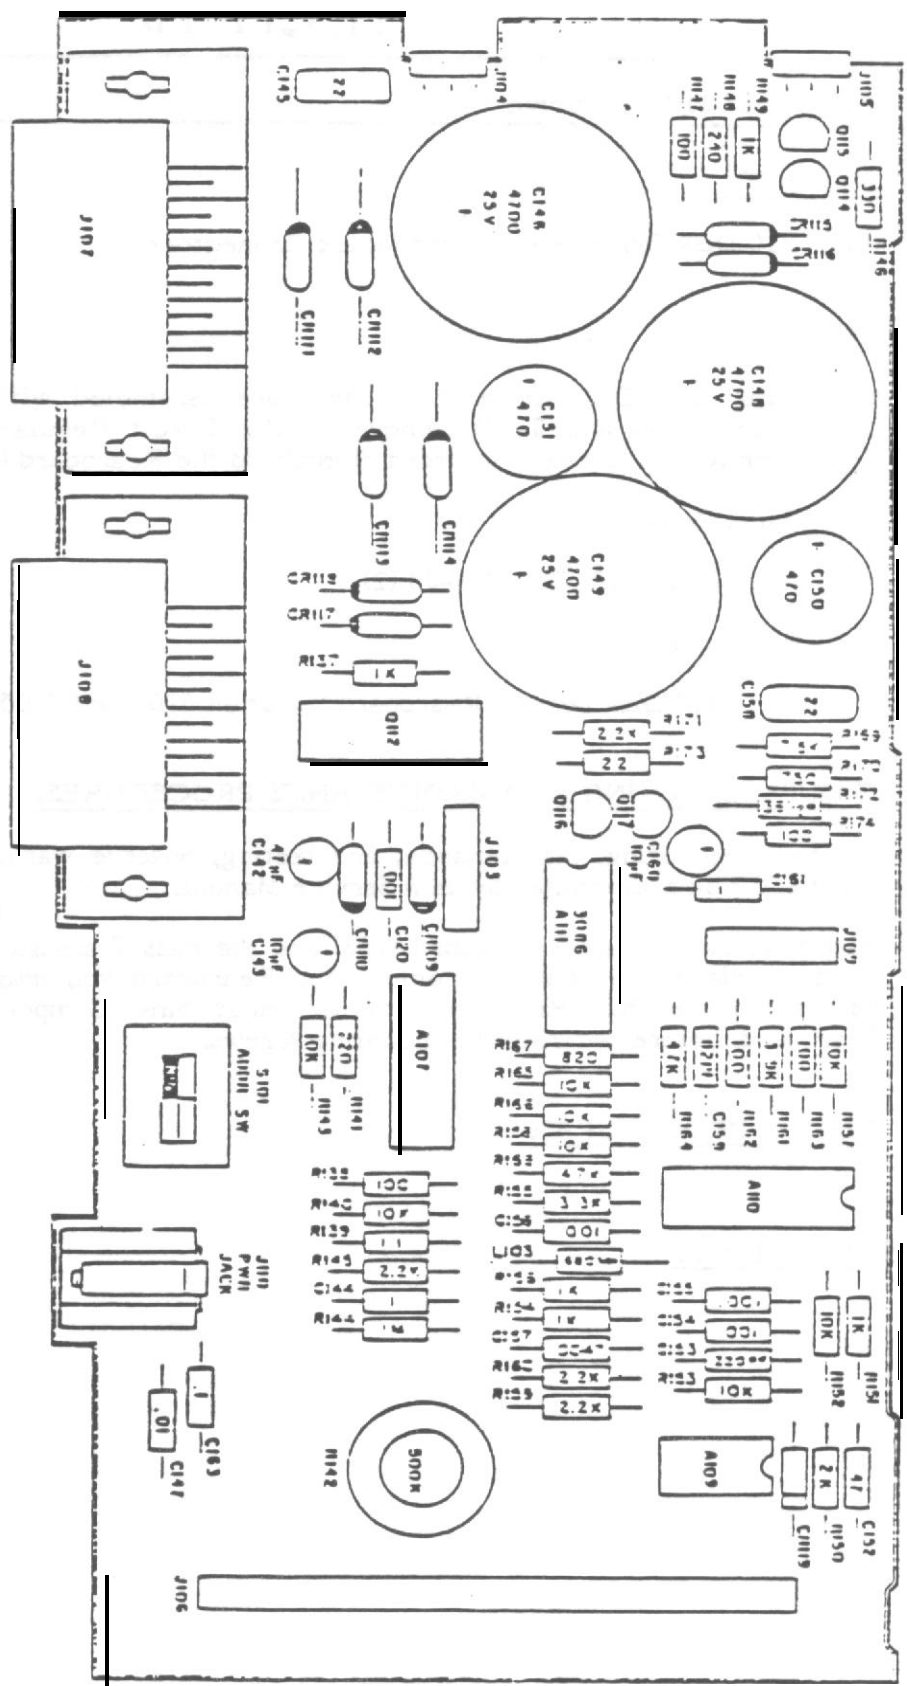
810 Rear Board
Silk Screen

New Atari 810 Disk Drive Rearboards are assembled with the two 3 Pin Molex Connectors (J104 and J105) removed. The 5 Volt Regulator (A108) and the Pass Transistor (Q113) are now soldered directly to the Rearboard (see Sii Screen an back).

Note that the Voltage Regulator (A108) and the Pass Transistor (Q113) are fastened to the base plate. In order to remove the Rearboard you must remove the mounting screws from each. Remember to use Heat Sink Compound when replacing the Rearboard, before securing the mounting screws.

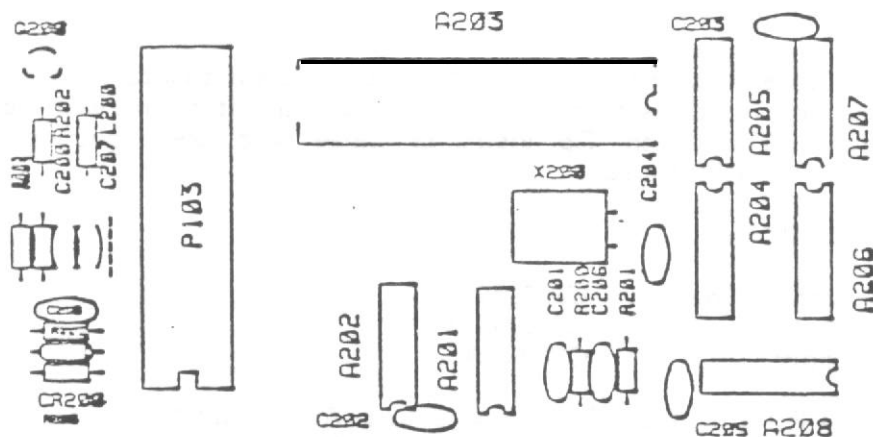
810 DATA SEPARATOR SILKSCREEN

Part Location - P103 on Data Separator Board, Atari Part No. CA017231, plugs into the sideboard location A105 on Atari Sideboard Part No. CA014834, where FDC 1771 (Floppy Disk Controller) is usually installed.

NOTE: These boards cannot be installed in the existing socket in sideboards not designed for data separator. Doing so may result in short or intermittent failures.

If a board is suspected, follow the standard troubleshooting procedure outlined in Atari 810 Disk Drive Field Service Manual, to check circuitry and alignment. If circuitry and alignment check out but board has many 144 errors or many intermittent errors, swap the data separator board in the unit with a known good one. This procedure isolates the problem to a faulty data separator board or faulty side board.
